## BALL JOINT OF A LOCK-GATE

The lock gate on the "Nieuwe waterweg" (see Figure 1) consists of two caissons which in case of storm or spring tide can be towed out into the canal and subsequently sunk to close the waterway. Both caissons are connected to large ball joints on the opposite banks.

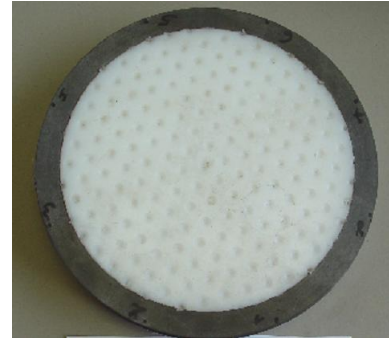
*Figure 1: Reinforced polymer disc*

Different solutions and material combinations were investigated at the Laboratory Soete. The proposed solution consisted of placing polymer (UHMWPE) pads in holes machined in the socket. Due to the large normal loads the polymer discs had to be reinforced to prevent plastic flow of the UHMWPE.

As the polymer discs had to function reliably under overloaded conditions during the large lifetime of the lock gate, the friction and wear behavior was investigated on a large tribological test-rig available at Soete Laboratory.

The test results indicated that this solution was acceptable. The polymer discs were installed on both ball joints and the lock-gate is up to today functioning as expected.

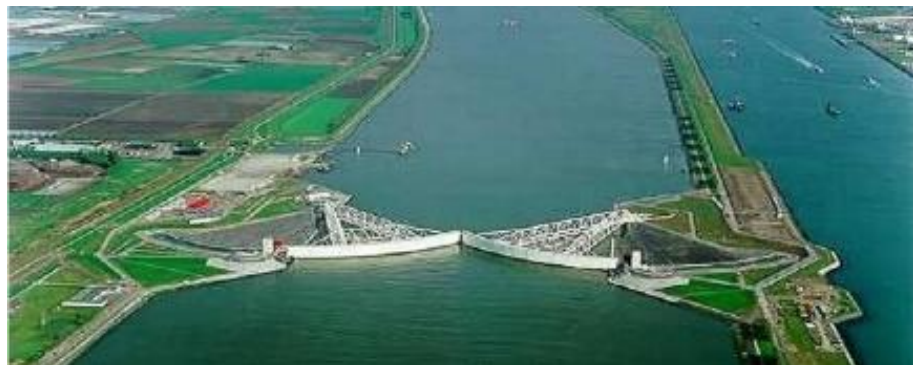
The two ball joints of a lock-gate consist of a ball with a diameter of 10 meters rotating in a faceted socket. The materials chosen during the design stage were cast steel for the ball and the socket, which were both coated with a lacquer containing MoS<sub>2</sub>. This lacquer should act both as corrosion protection of the steel substrate and as a lubricant

*Figure 2: Lock-gate on the "Nieuwe waterweg", Rotterdam (the Netherlands)*

During the first operations of the sea lock cold welding spots were observed on both the steel ball and socket. Each time the damaged zones were grinded out, material welded on, polished and a new coat of lacquer was sprayed on in situ. As this reparation was a costly operation, a new material choice for either the ball or the socket was in order.
